Technical Assessment - Site Observations

Colonial Beach /Permit Number: VA0026409

December 9, 2023

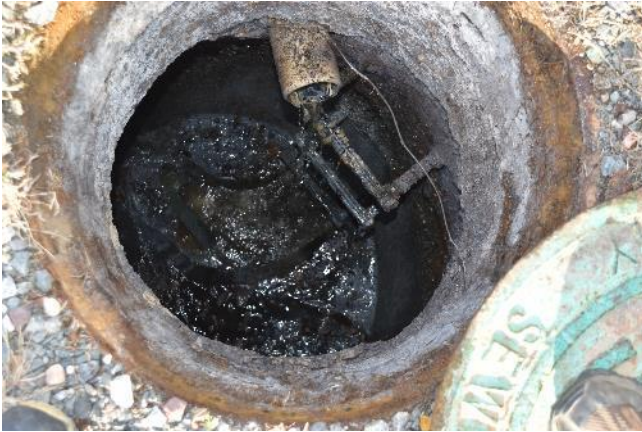
Manhole before a major lift station

An example of a manhole that would benefit from grout and resealing. From the view of the picture, a cable was bored through the joints in the structure.

For example, the location is off the road and subject to surface water runoff.

- Reinvest in the collection system. It is recommended to prioritize mainlines that are ideal for relining or replacement and manholes subject to inflow and infiltration that could be sealed.

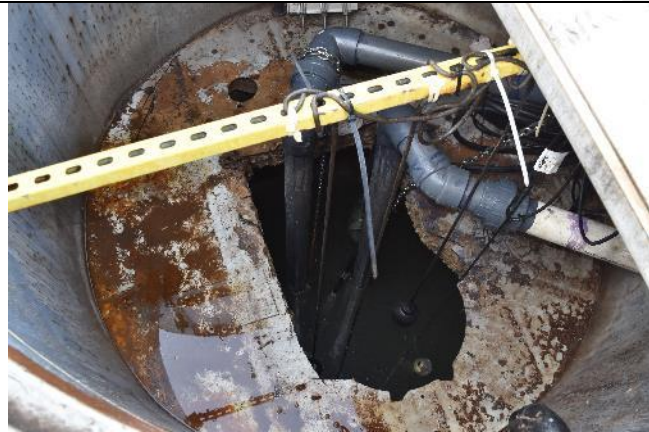
Lift station wet well

Example of the town's efforts - rehabilitation of the pipework and station controls.

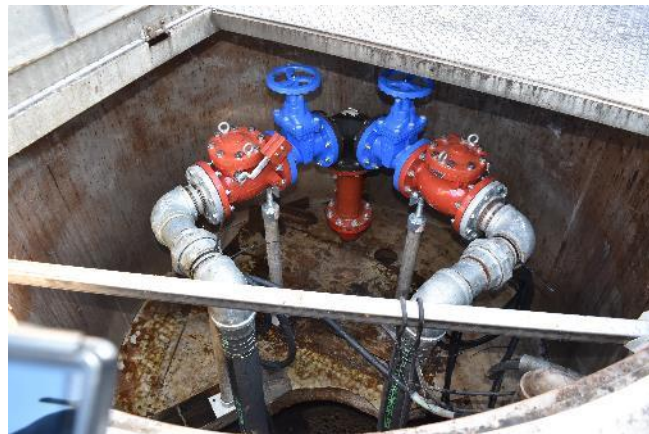
Lift station wet well

Example of the town's efforts - rehabilitation of the pipework and station controls.

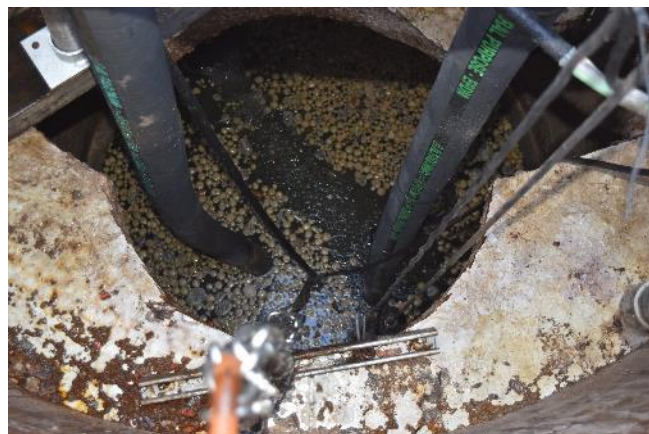
Lift station grease ball formations

- The lift stations indicate significant amounts of fat, oil, and grease (FOG) in the collection system. Staff indicated they know trouble areas and no administrative or building code regulations.

A typical station observation is to see the grease in a ball form.

Other pictures indicate stations with grease mat that may depend on the location in the system and the type of velocities in the pipes.

- It is recommended to establish a FOG (Fat, Oil, and Grease) program within the Colonial Beach service area. The effort requires minimum inspections to determine where the grease loadings occur and increase maintenance methods to eliminate costly backups. It is also recommended that lift stations be cleaned more frequently to remove the grease from getting pumped around the system. Regulations must be established to ensure food service entities have the proper grease separators to eliminate the burden on the town. Universal plumbing and building standard codes can provide this, along with a program for compliance that results in surcharges when users do not meet standard regulations.

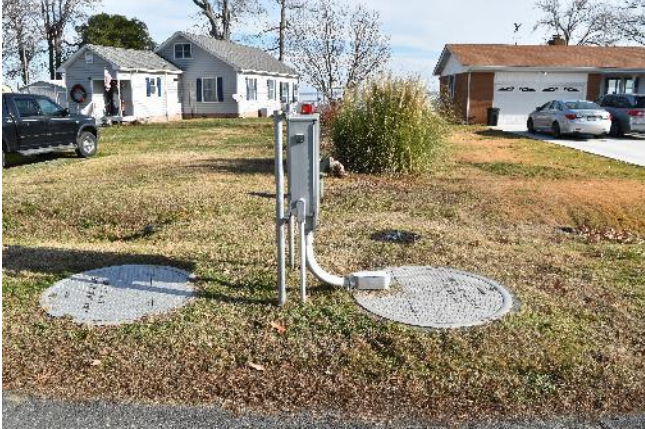
Residential lift station location

An example of one of the stations that have been recently updated

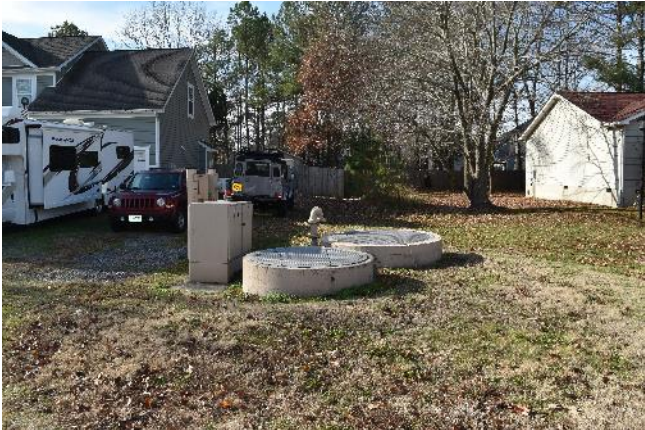
Residential area lift station

Example of a station in residential area.

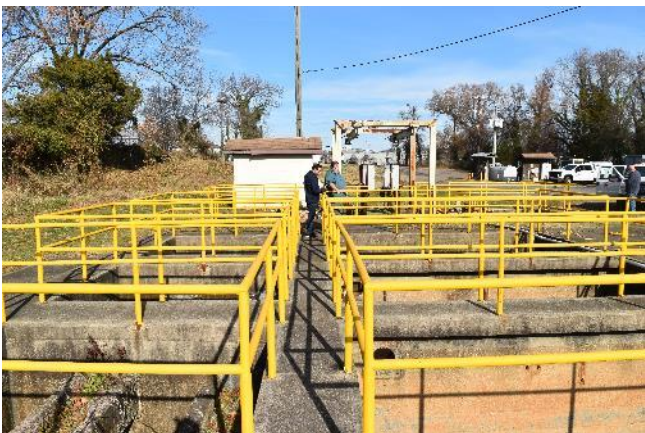
The original treatment plant site

Tanks converted to a lift station

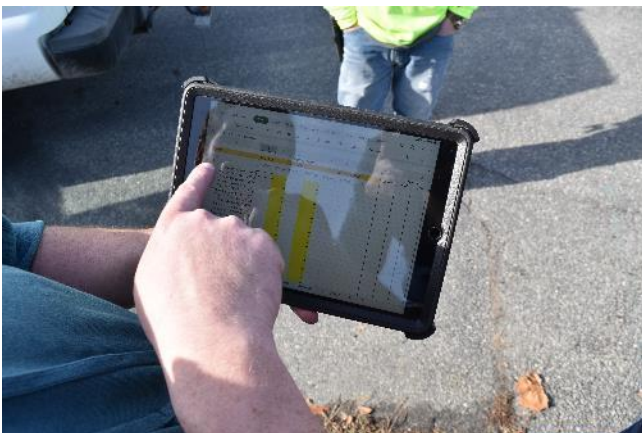
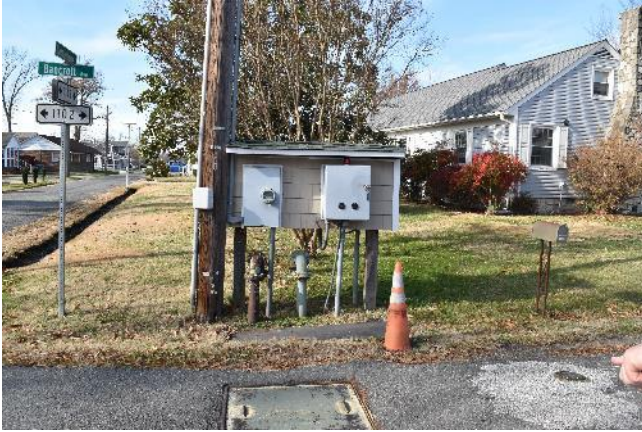
Lift Station in Right of Way

The pump wet well for this station is in the roadway adding complexity for service. Consideration of relocation or, elimination if possible, in conjunction when new developments come online.

vault in the roadway, subject to surface runoff and access issues. Evaluate the operations to eliminate or relocate.

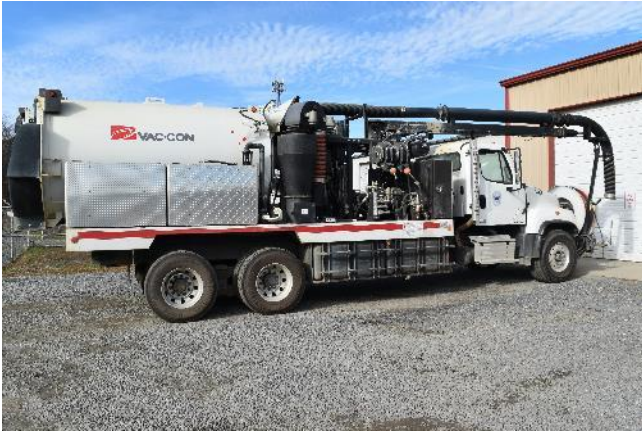
Vac-Con Truck

An example of service commitment by Colonial Beach is using this truck frequently.

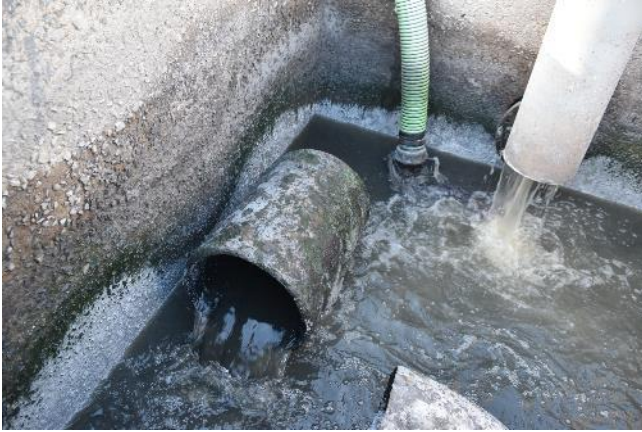
Influent Flow Channel

Typical influent flow to the facility indicates septic conditions.

Septic receiving station at headworks.

- Observed corrosion to open air and enclosure indicates elevated levels of hydrogen sulfide, likely from the septic conditions of the sewage. Considerations for air handlers for enclosures. Consideration for liquid pretreatment of the influent as it comes into the headworks structure. Analyzing the raw sewage's condition and understanding the chemistry related to the observed corrosion is recommended.

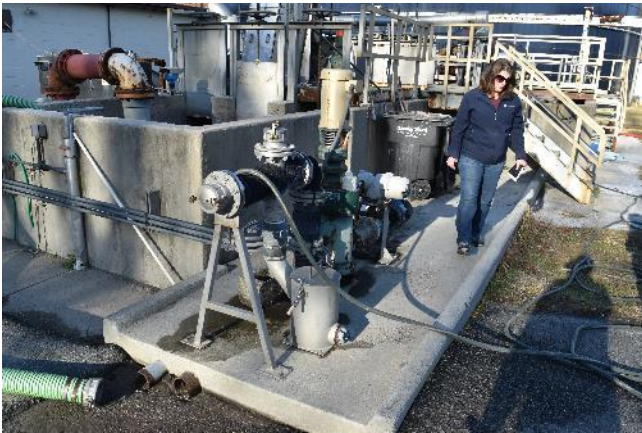
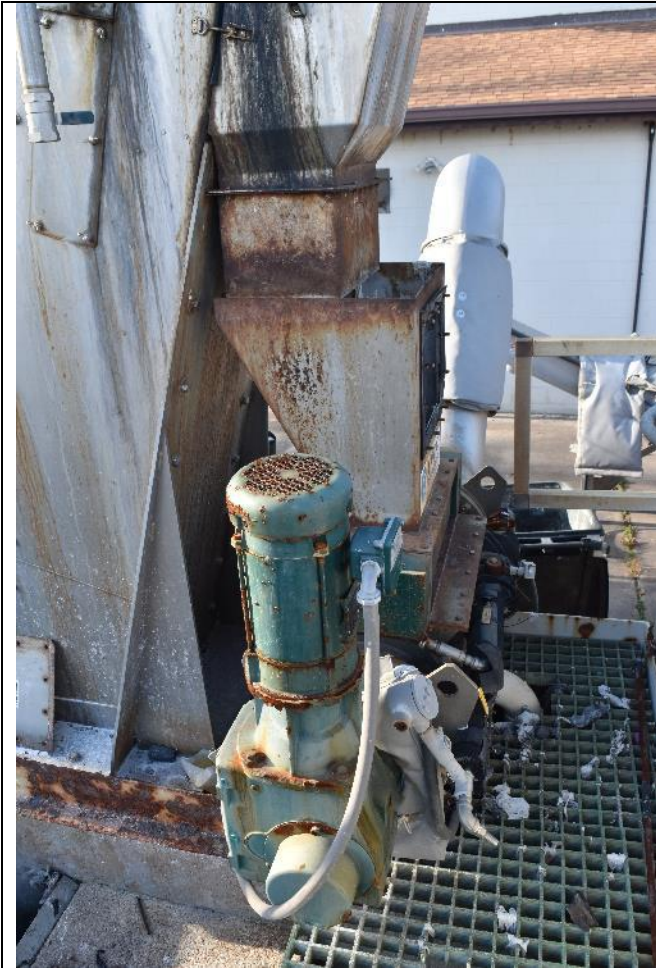
Headworks - Influent Flow Screen, Grit System, and Vac-Con Dump Station

- The Vac-Con dump station is undersized for the demand. It does not have enough capacity and containment to dump the debris bed on the truck effectively.

The influent screen is out of service due to a failed compactor motor. In this area, bags of hydrated lime are added periodically to the influent. Recommend fixing the motor to use the screen and creating a water and lime slurry to slow-feed into the flow to ensure proper dispersion.

The grit removal system is offline and must be returned to service. The debris

needs to be removed to ensure proper operation. Note the amount of corrosion at the influent structure while in open-air conditions. This is an indication of septic conditions and high hydrogen sulfide concentrations.

The dump station is undersized for utility needs and needs to be expanded.

- Repair and reestablish all offline components to improve the treatment process. The recommended equipment is the screen system, grit removal, belt filter press, decant station pumps, RAS pump, and replacement chemical feed lines where garden hoses were installed. It may be ideal to purchase a 0.5-inch water service line in increments with as few couplings as possible. Once all equipment is entirely online, a testing program for process control would provide an excellent return.

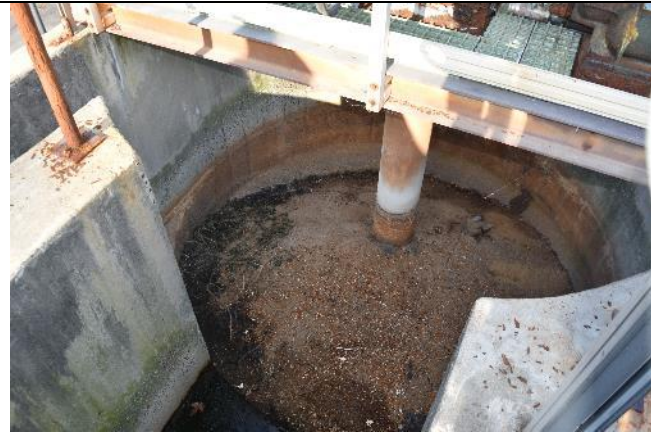
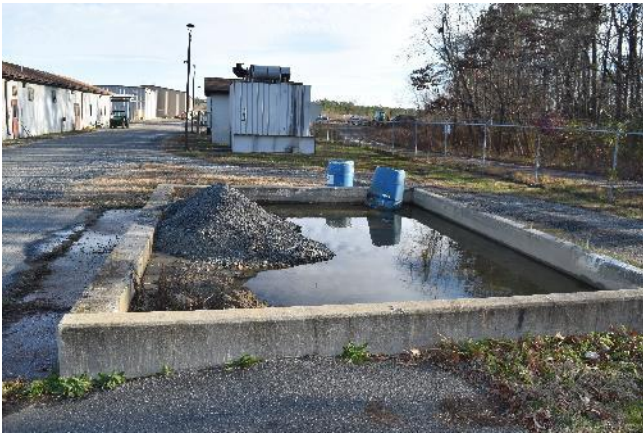
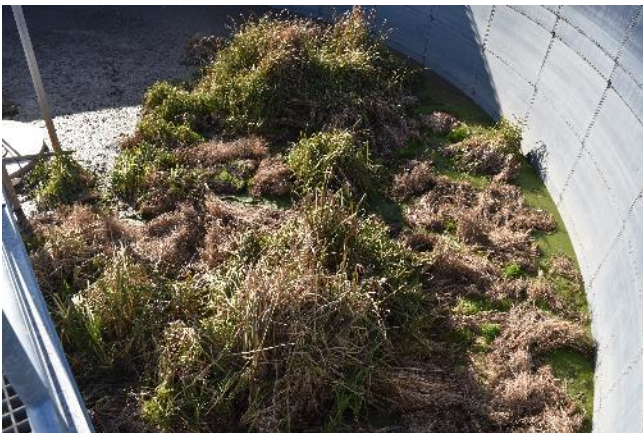
Flow Equalization Basin (FEB)/Anoxic Reactor 1A and 1B

Vegetation growth in tanks 1A and 1B requires removal as soon as possible as it is robbing tank capacity and causing component fouling.

- Housekeeping at the treatment facility is needed. While the staff is busy, an attitude of stewardship is recommended to ensure presentation at any time. The vegetation must be removed from the tanks – this may require completely removing the tanks from service to allow for ample cleaning as soon as possible. Cleaning of the structures ensures positive presentation.

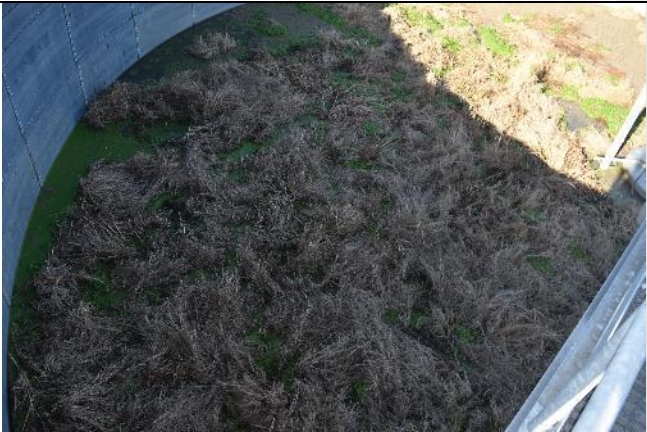
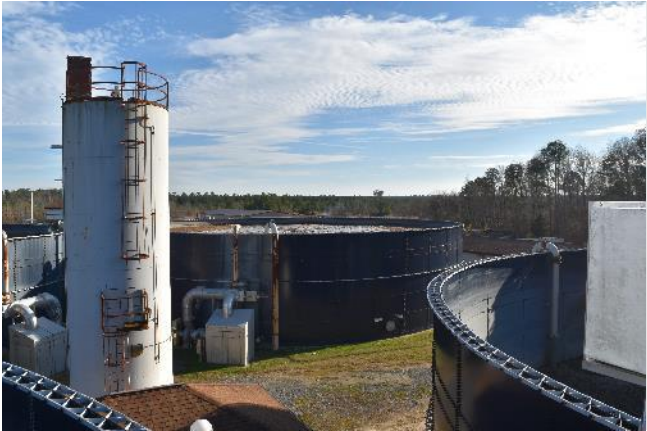
Lime Silo view from Anoxic to Nitrification

Example of coatings failing on the lime silo and exposed pipe. These need attention to protect the integrity of the metal and improve its appearance (a good appearance is critical for instilling a sense of pride in the operations staff).

An example of coatings failing on handrails and walkway structures – a potential safety concern.

- Rusted pipes and structures should be a focal point to ensure service life.
 - The laboratory should be cleaned routinely to not interfere with testing.

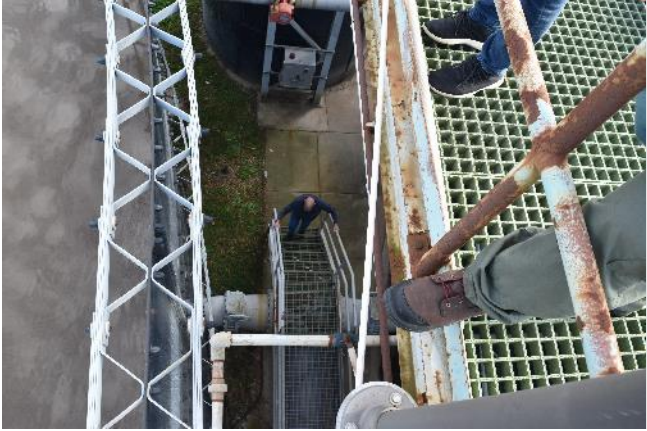
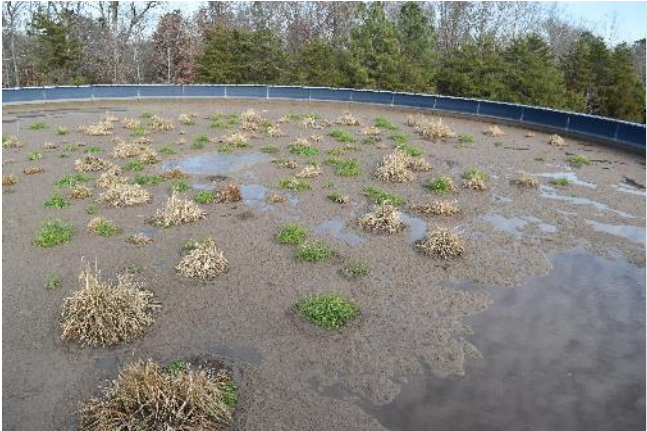
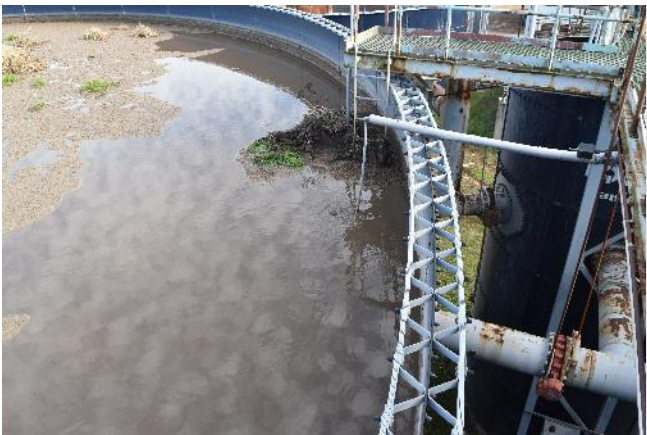
Nitrification Reactors 2A and 2B

Vegetation growth and carry-over to this point in the process. Removal should be expedited to prevent treatment issues and overflows as it robs tank capacity and contributes to component fouling.

Examples of exposed pipe that is losing coatings.

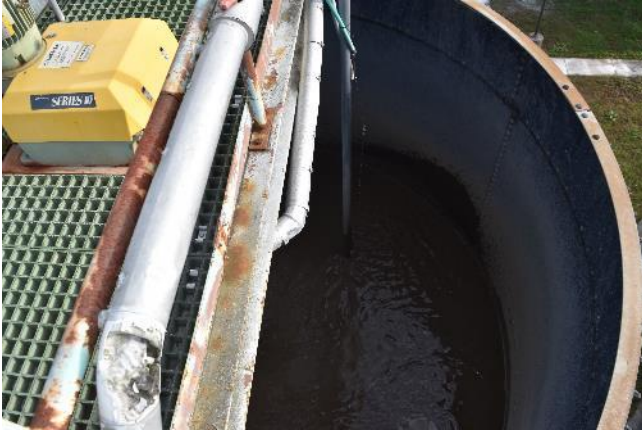
Flocculation Diversion Tank

On the day of the site visit, a polymer solution derived from a dry mix was flowing into the tank. There was evidence of insufficient residual polymer to create good floc to help with chemical settling. Due to pipe failure from the feed building, garden hoses are being used to transport the polymer solution.

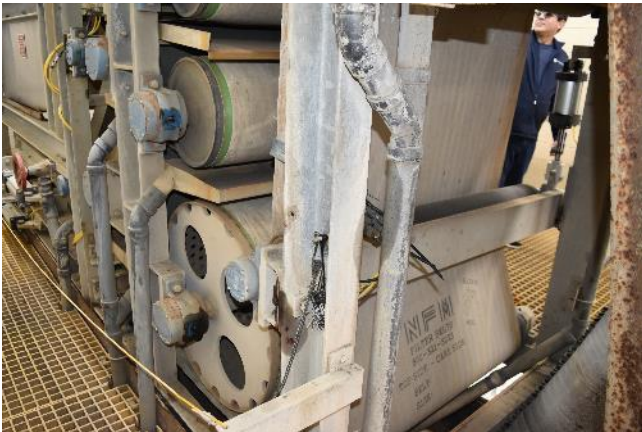
Belt Filter Press

The belt filter press is out of service due to an airline failure.

The air filter or regulator has duct tape around it, indicating it may leak; recommend evaluating replacement.

Note the corrosion to the metal portions of the support beams.

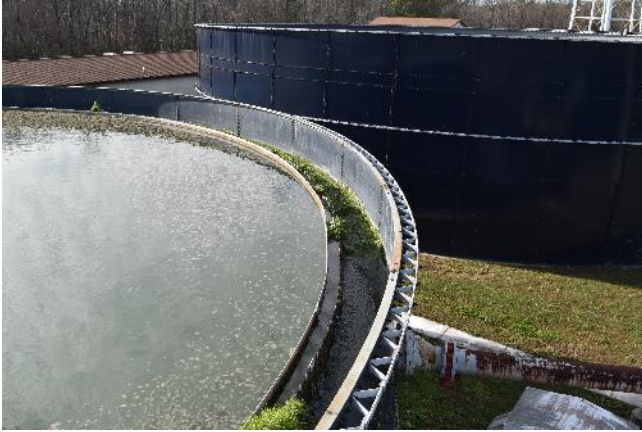
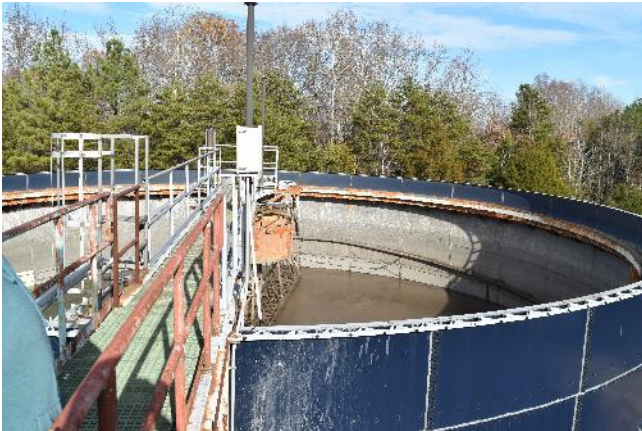
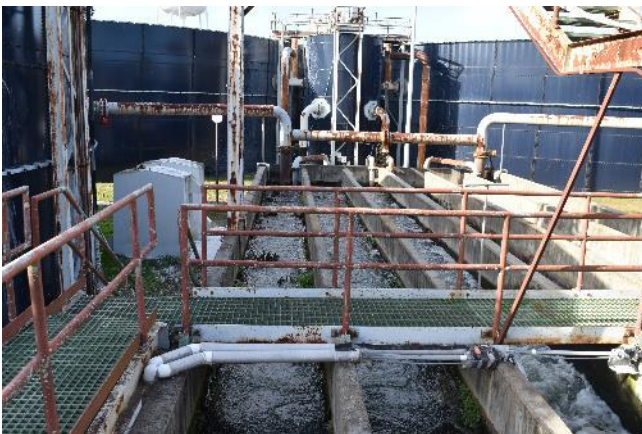
Clarifiers, Post Aeration, and Scum/Backwash Station

Example of a clarifier in service with vegetation in the launder. Efforts have been made to remove the vegetation.

Example of a clarifier out of service.

Algae and vegetation growth in the post-aeration tanks. Notice the handrail and metal corrosion.

Scum and filter backwash station flow and standby pump set up with automatic float control.

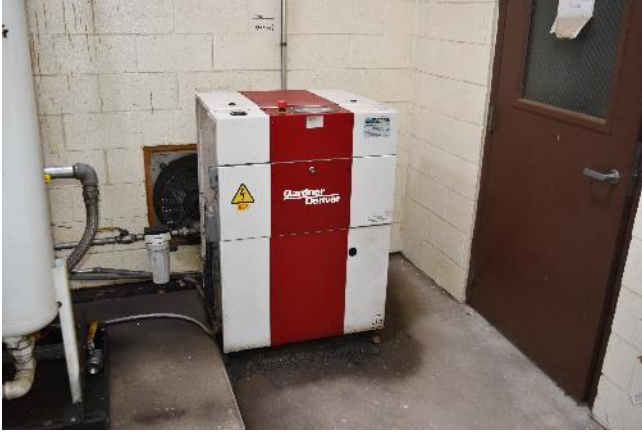
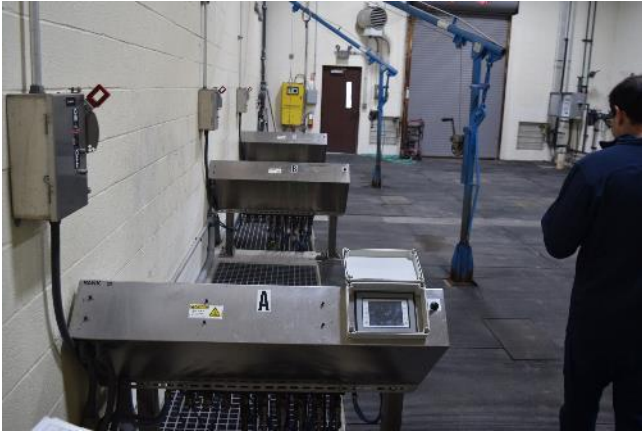
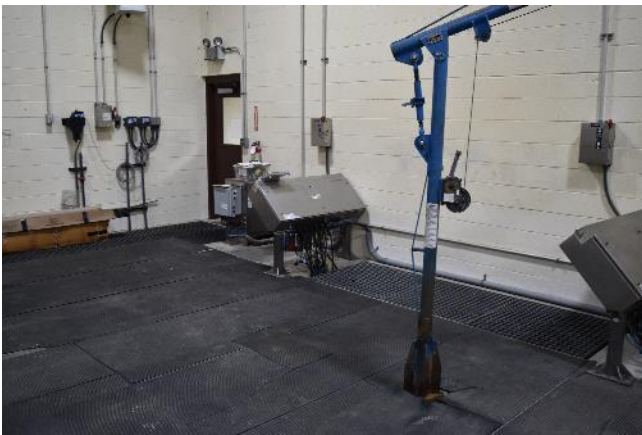
UV System and Filter Building

The banks of modules for disinfection.

The quantity and health of the media are unknown, but the comparison in pre- and post-filter indicated little change in water quality to the naked eye.

- The post-filter effluent opacity indicates that the filters may not perform per design. The media health and quantity need to be evaluated. The water quality means that the filters are not operating as a benefit for the facility at the time of observation. There could also be a chemistry issue that needs to be evaluated. It could be chemical doses are wrong or not required, or due to lack of process control. The biological system is robust and, with process control and optimization, should meet the conversion and separation needs at the facility with only minor chemical enhancement.

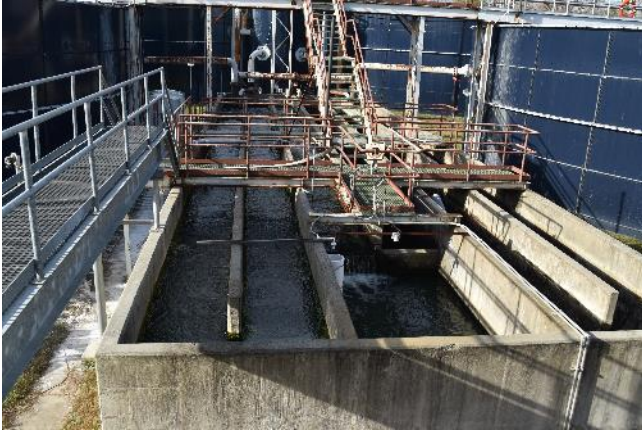
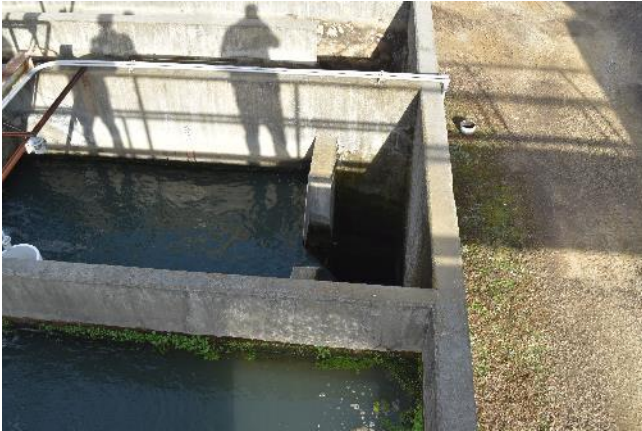
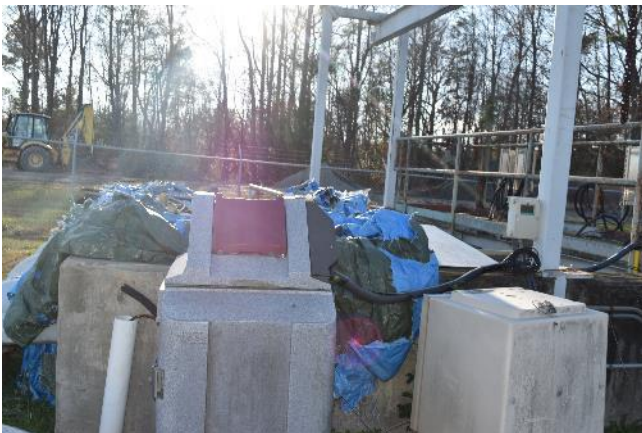
Effluent Discharge Structures

- The opacity of the effluent on the day of the visit was not as transparent as expected, given the filters. The media for the filters are expected to be original and require inspection for media health and quantity.

The post-aeration basin before delivery to the effluent pump station.

The effluent quality on the day of the visit lacked the transparency expected with a filtered product. The dissolved solids content may be high, or the chemistry is out of balance, which in a filter process would indicate high water reject flows.

Effluent sampling station before pumping to the bay.

Cloudy effluent at the discharge pump station. The effluent expectation would be higher quality post-filtration. Again, this indicates that the media is at the end of its useful life or the plant's chemistry is off.

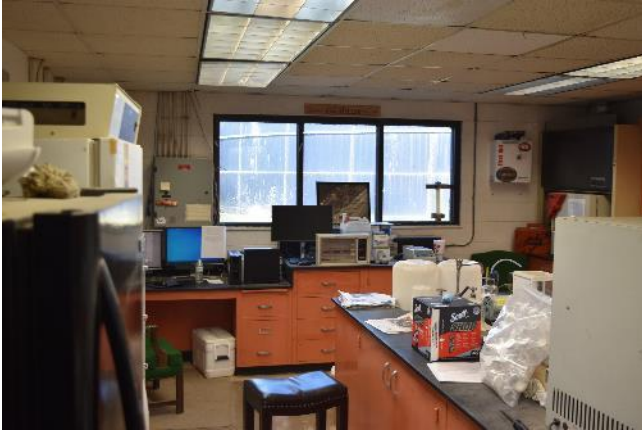
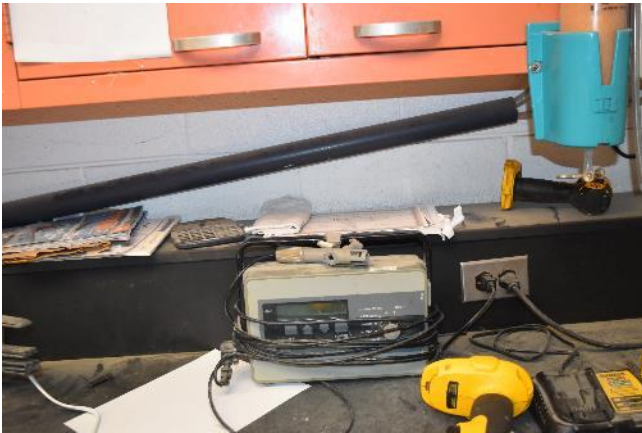
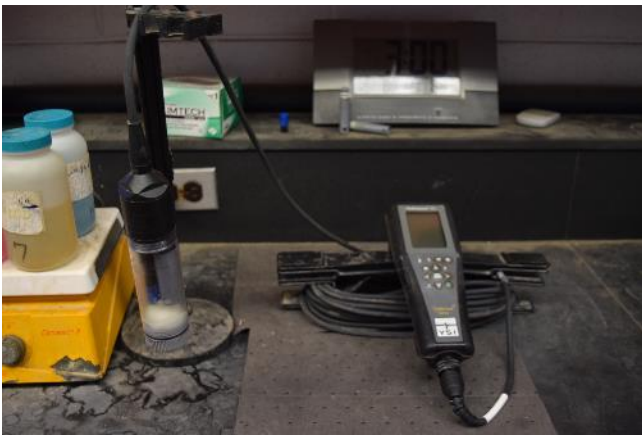
Laboratory

The laboratory indicates a lack of organization and overall cleanliness expected for (at a minimum) process sampling at a facility of this nature.

The facility logbook was noted, and information was recorded.

Verify what analytics are conducted in-house and what clutter could be removed. A good lab is a clean lab, even if it is only used for process control.
