Technical Assessment - Site Observations

Colonial Beach /Permit Number: VA0026409

December 9, 2023

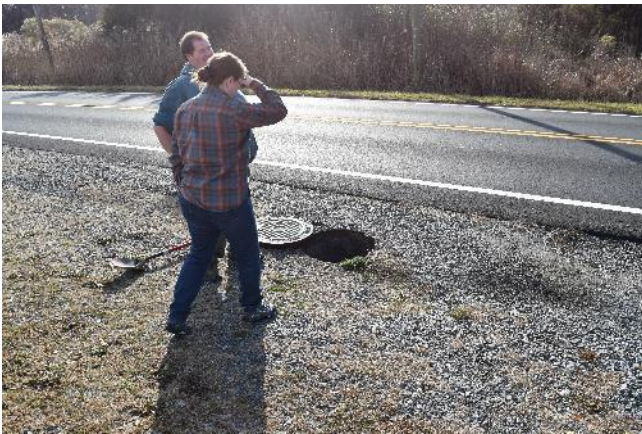
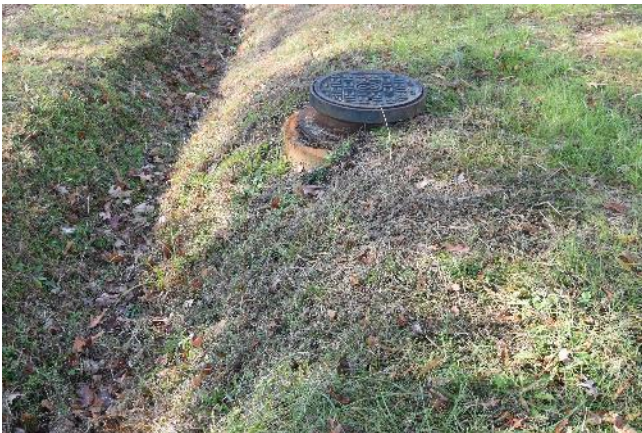
An example of a manhole that would benefit from grout and resealing. From the view of the picture, a cable was bored through the joints in the structure.

For example, the location is off the road and subject to surface water runoff.

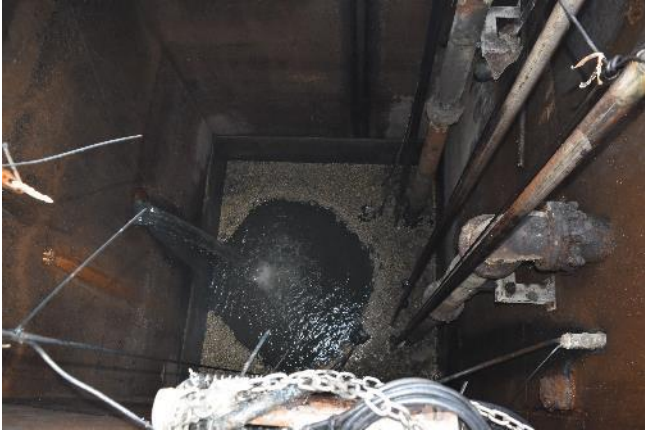
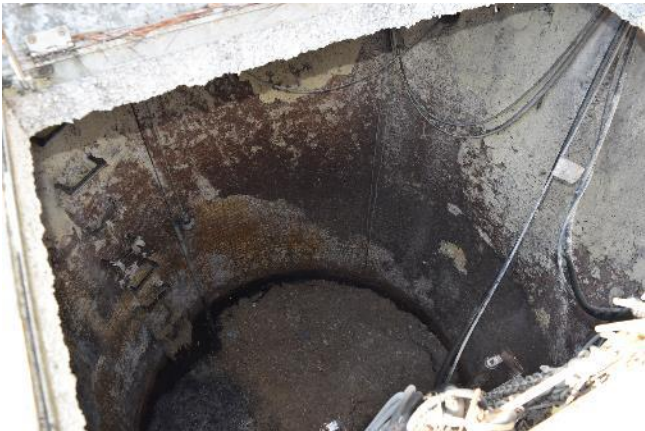
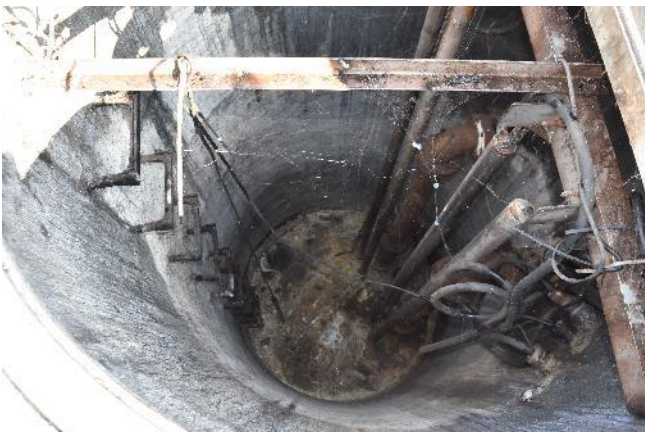
Other pictures indicate stations with grease mat that may depend on the location in the system and the type of velocities in the pipes.

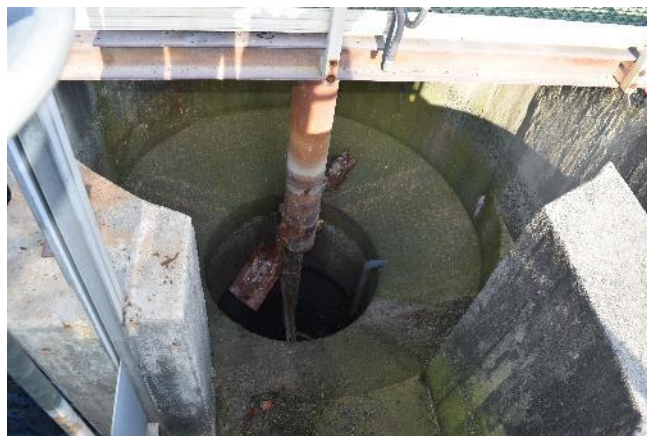
needs to be removed to ensure proper operation. Note the amount of corrosion at the influent structure while in open-air conditions. This is an indication of septic conditions and high hydrogen sulfide concentrations.

The dump station is undersized for utility needs and needs to be expanded.

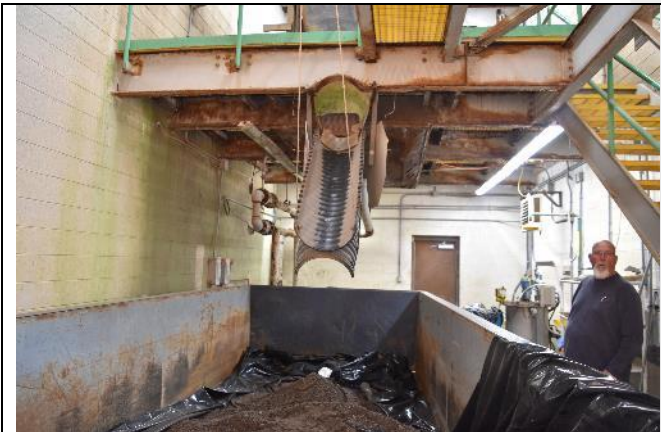
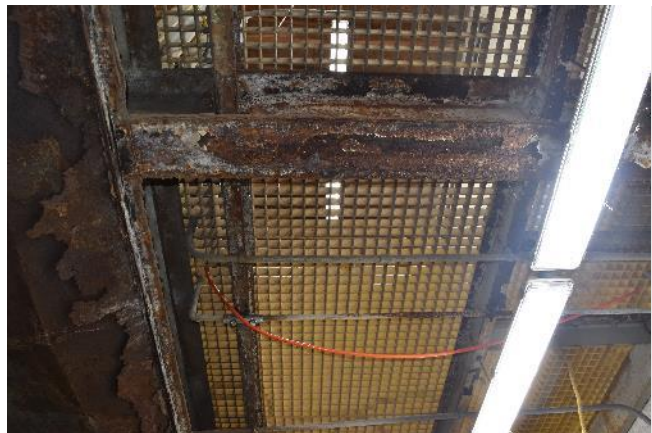
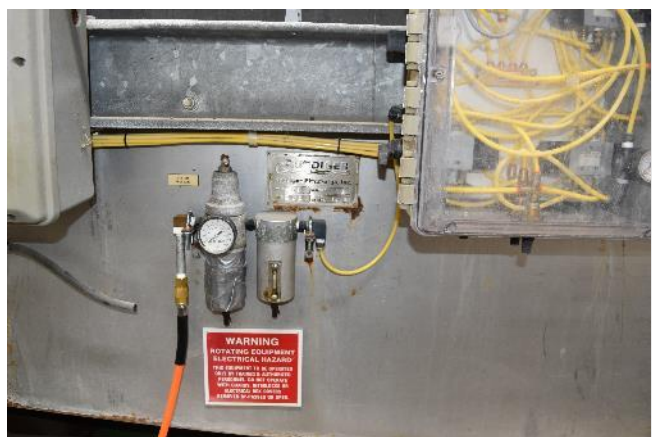
Note the corrosion to the metal portions of the support beams.

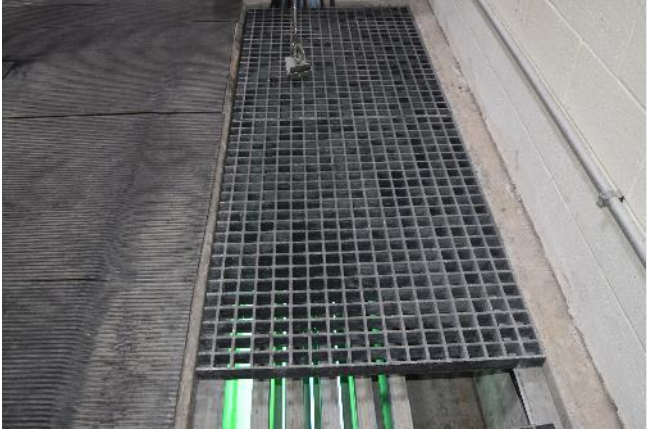
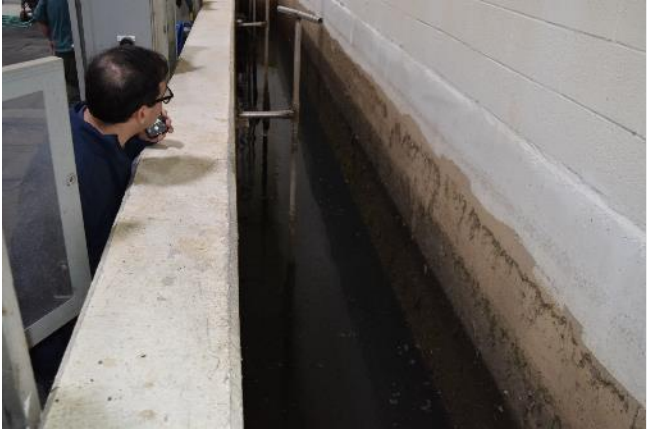
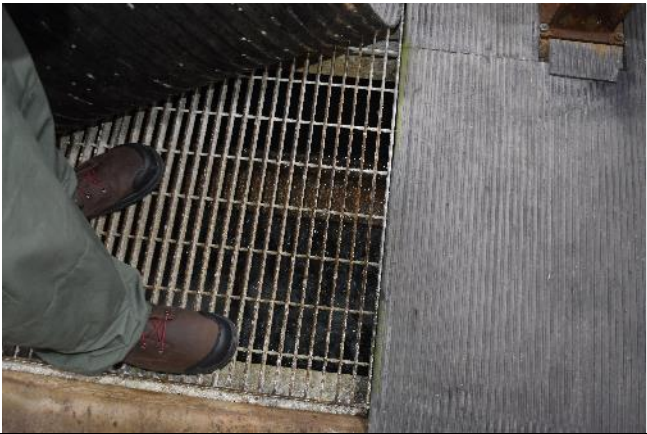
The banks of modules for disinfection.

The quantity and health of the media are unknown, but the comparison in pre- and post-filter indicated little change in water quality to the naked eye.

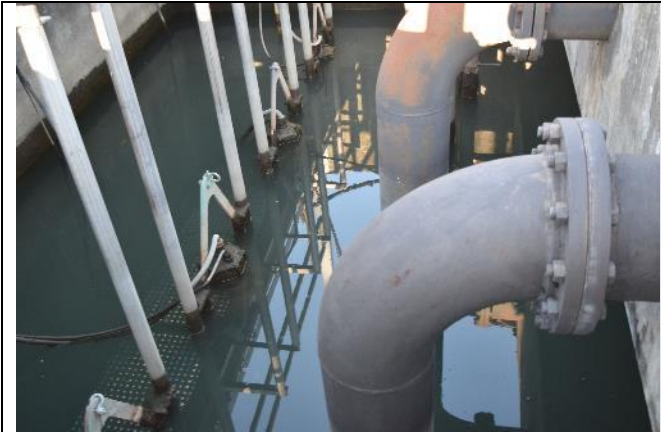
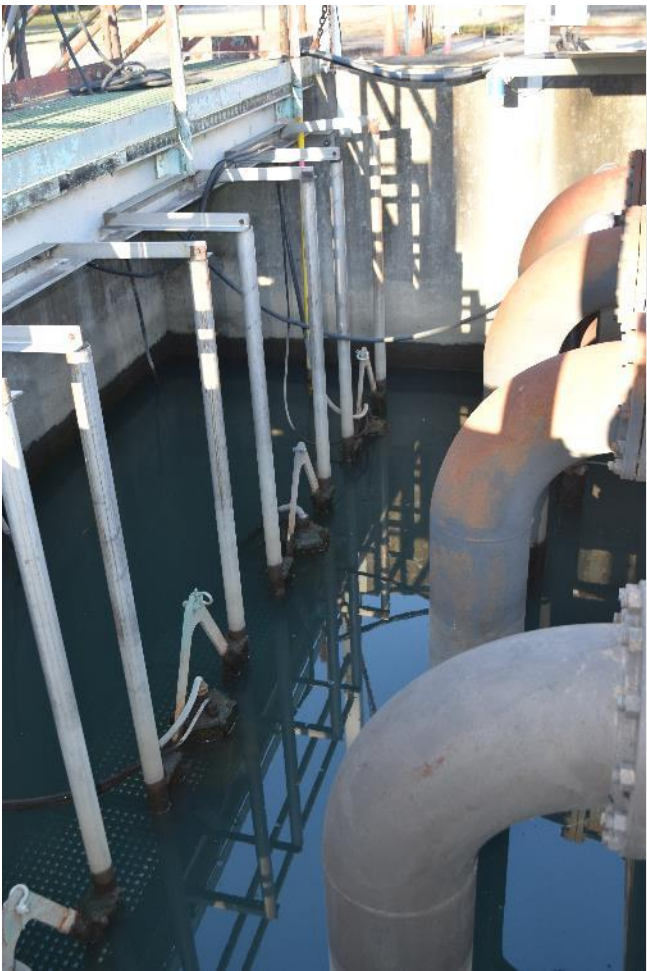
Effluent sampling station before pumping to the bay.

Cloudy effluent at the discharge pump station. The effluent expectation would be higher quality post-filtration. Again, this indicates that the media is at the end of its useful life or the plant's chemistry is off.
